FISHING CREEK DAM

INVENTORY NUMBER NDS MD. 16

## PHASE I INSPECTION REPORT

by  
BERGER ASSOCIATES, INC.  
CONSULTING ENGINEERS  
HARRISBURG, PA

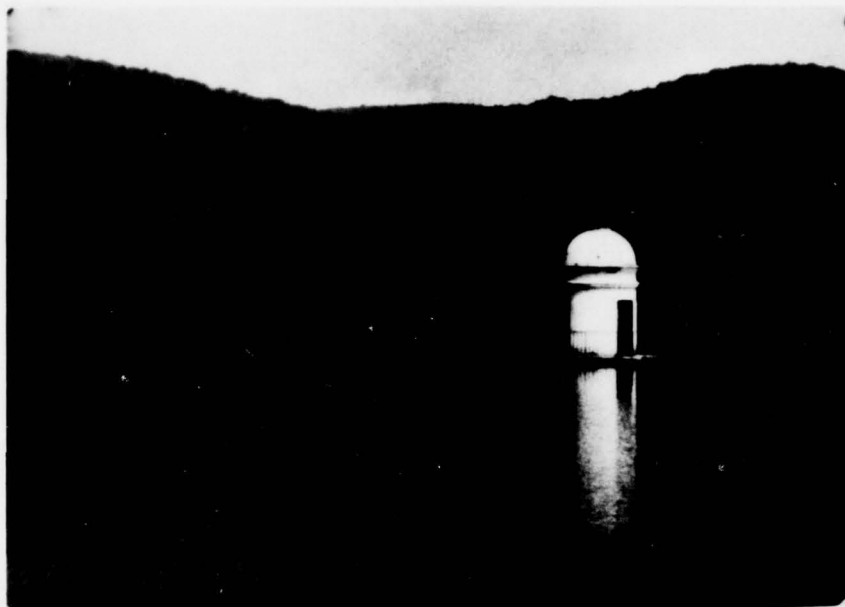
It was noted that the boat launching area is on the south side of the lake, which is inaccessible during flood events. Since the intake tower and sluice gate operating mechanism are reached only by boat, this would prevent opening of the sluice gate during flood events. The operating platform of the intake tower is below the top dam elevation.

RESERVOIR AND  
CONTROL TOWER

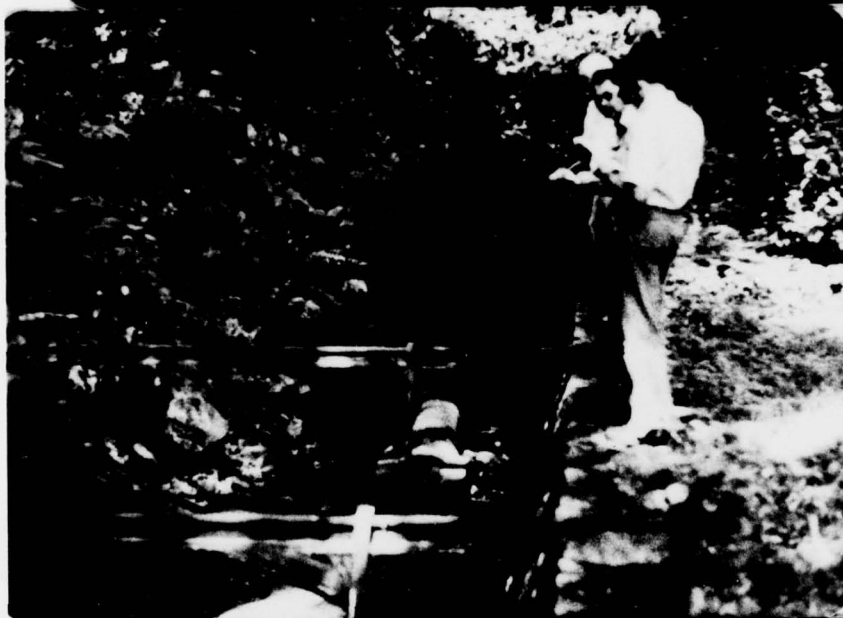
A third source of leakage was identified in the outlet tunnel at a point 157 feet upstream from the downstream face of the outlet structure. Inspection of this leakage source noted a break in the floor of the tunnel located about 18 inches from the left wall. The break is about one-inch in diameter and water was spurting to a height of about 5-inches above the the floor of the tunnel. The water at its source point is clear but is rust colored at the outlet due to sediment in the bottom of the tunnel. Refer to Sketch #1, attached to the visual inspection report (Appendix A) for all seepage points.

2. The break in the bottom of the outlet tunnel and its associated leakage is probably again due to water flow below the foundation. The 5-inch artesian flow indicates low pressure at this point. The condition is of concern and should be repaired at once.

Steady discharge from outlet due to break in bottom of conduit 157 feet from the downstream end. Rust colored water. Extensive calcium leaching on inside of conduit.

CONDUIT

1. The spillway discharge and reservoir storage capacity should be evaluated and steps taken to improve the present seriously inadequate condition.
2. The break in the outlet tunnel should be repaired at once.

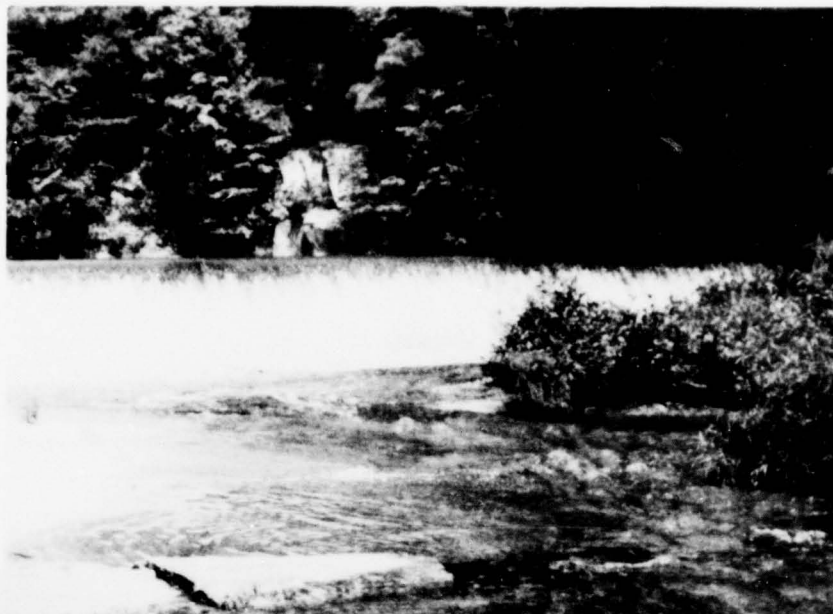
The existing spillway is a concrete ogee section 70 feet in length. Aside from some deterioration of the concrete surface, this structure appears to be in sound physical condition. There were no signs of major distress. The concrete apron below the ogee section leading to the discharge channel has numerous cracks of sufficient size to allow growth of weeds and brush. The spillway channel is excavated in natural rock. The discharge from the spillway cascades over the exposed rock to the outlet channel below. There is no stilling basin.

The physical appearance of the spillway is good, although there is some deterioration of the surface where aggregate is exposed as a result of weathering. The abutments are sound. Its discharge channel has a number of slabs which are cracked and have weeds and brush growing through the openings. The energy dissipation is accomplished by the discharge falling over a rough excavated rock channel. There is no stilling basin.

SPILLWAY WEIR

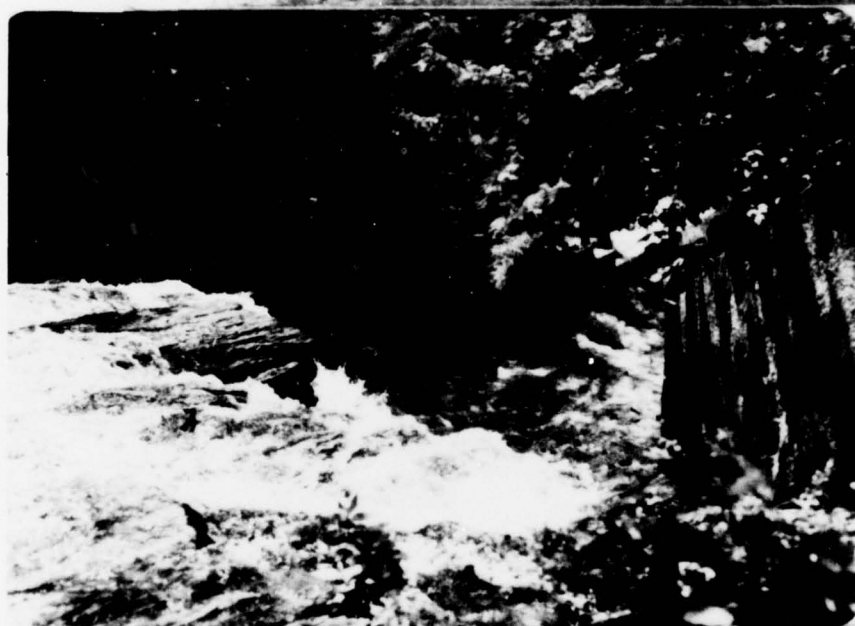
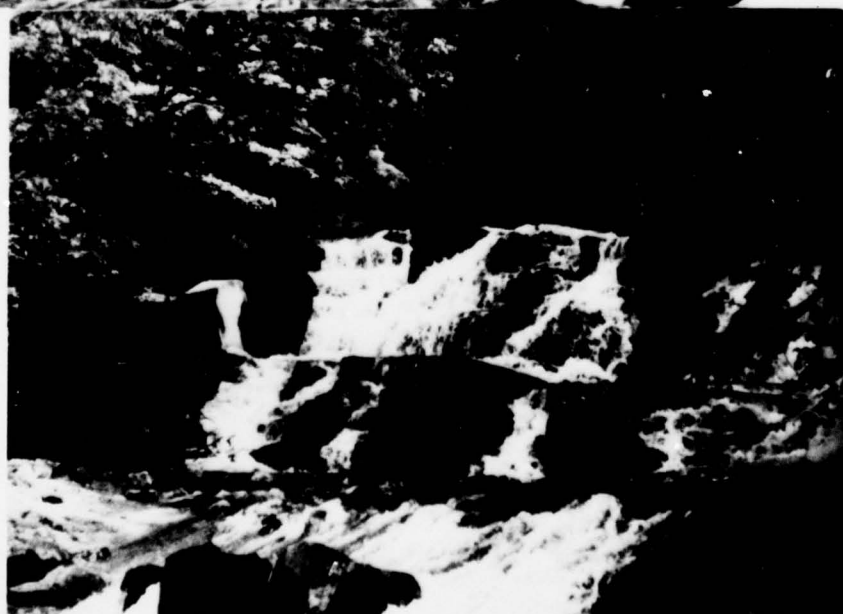
A steady flowing pipe was observed located in the right spillway channel wall approximately 100 feet downstream from the dam. The

source of this discharge is unknown. The owner's representative indicated that pipes were installed in this general area to improve a previous wet condition during the repair of the wall after the previously mentioned 1976 storm.

SPILLWAY

3. The apparent break in the foundation drain from the toe of the embankment to the spillway channel should be located and repaired.
4. The cracks in the spillway outlet channel should be repaired to prevent undermining of these units during high flows.

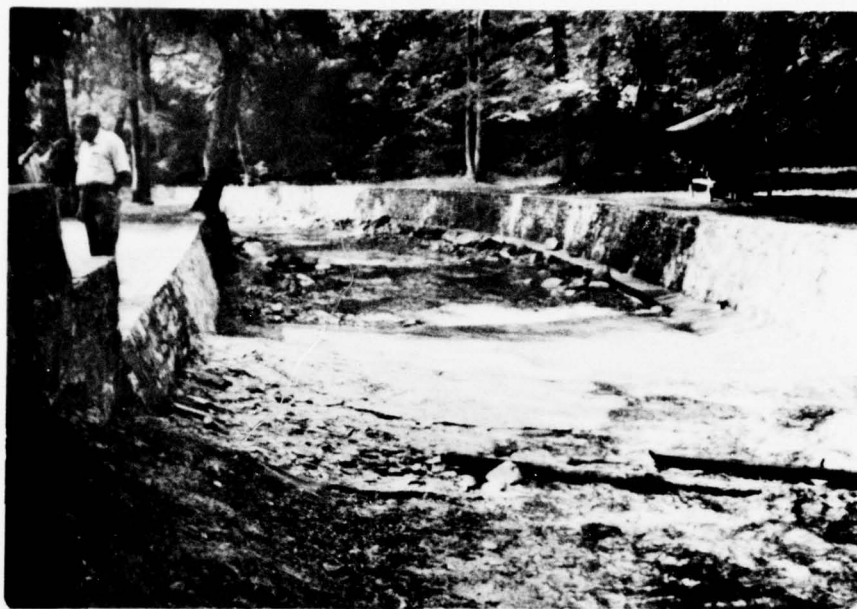
The downstream channel is natural mountain stream conditions, with stoney bottom and trees and brush to the edge of the channel. Summer cottages and some permanent residences are adjacent to the stream and in the flood plain. It is estimated that about 150 residences with a population of 400 to 500 persons are located along the stream. Public camping is permitted adjacent to and downstream from the dam embankment.

DOWNSTREAM CHANNEL
